Keeping track of corrosion

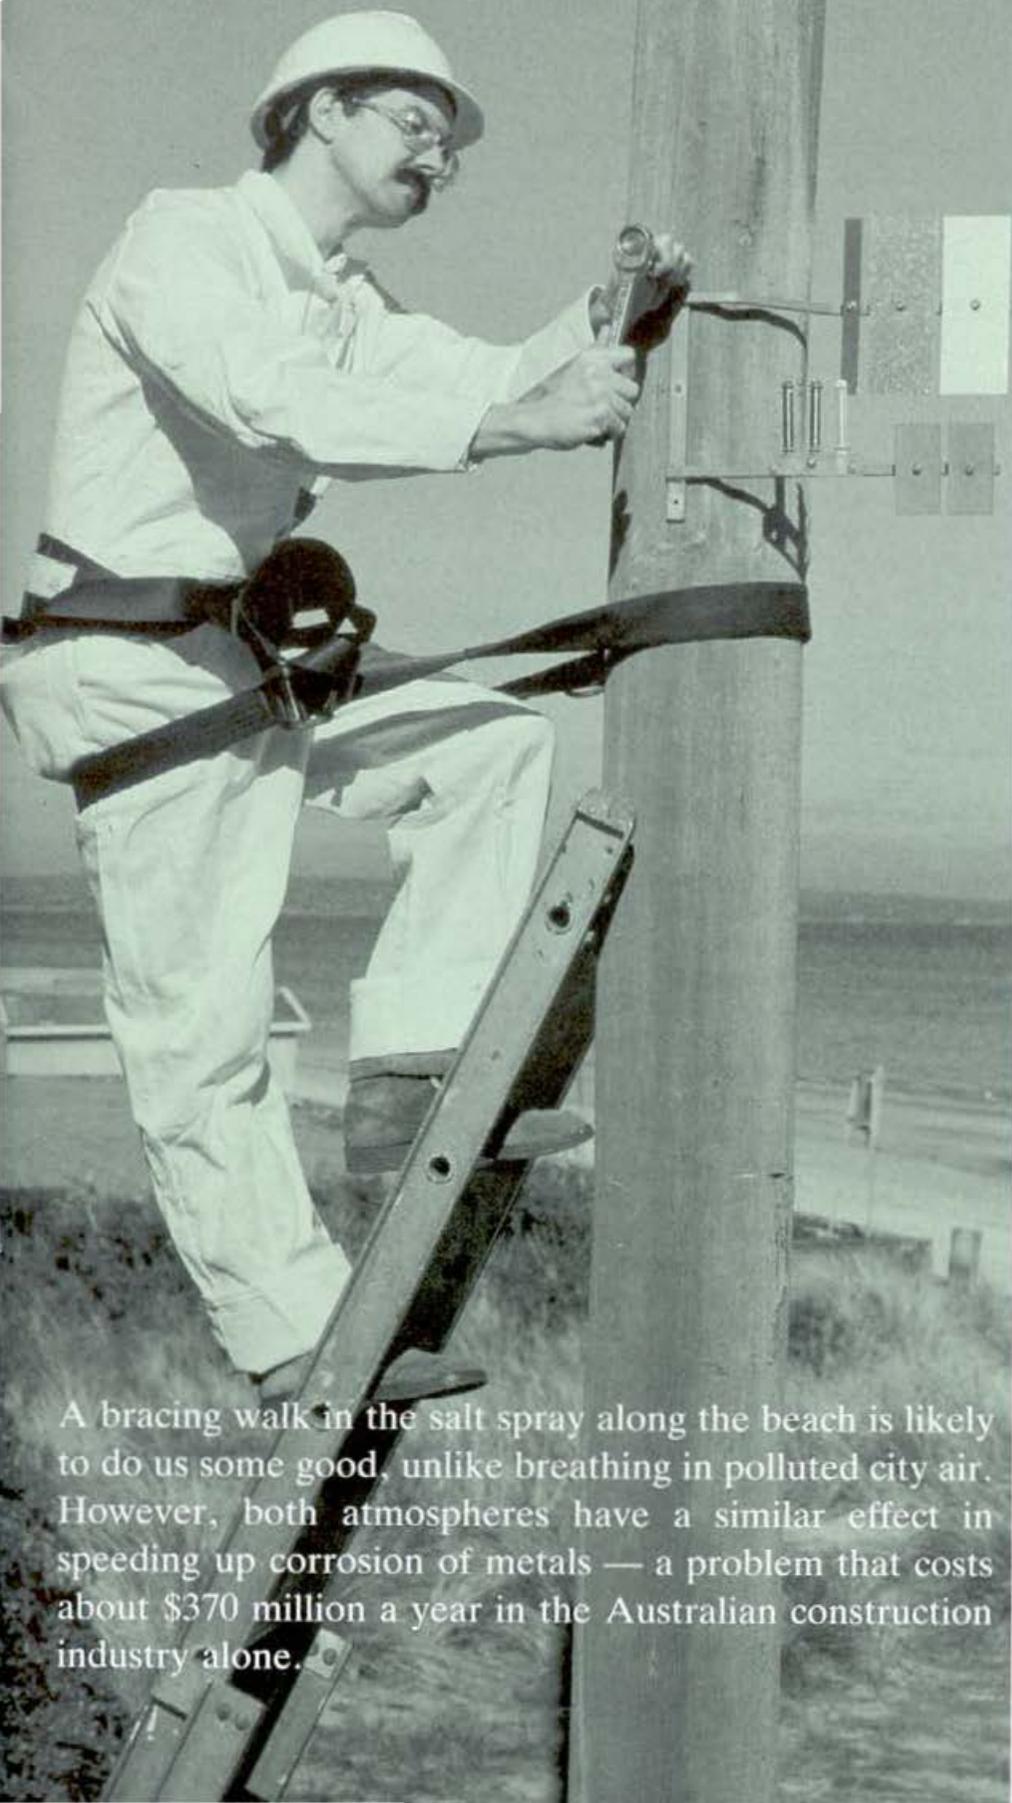
Mr George King fixes specimens to a power-supply pole at one of the Melbourne beachfront sites.

To compare the performances of mild steel, low-alloy copper steel, galvanised steel, and aluminium-zinc-coated steel ('Zincalume'), Mr King selected 68 sites on a 2-km grid in the south-east of Melbourne to include a broad cross-section of conditions from 'moderately severe marine' to 'rural'. This approach lets him confidently establish the relative performances of different materials. He mounted specimens of each steel, so that they faced north, on brackets fixed 3-7 m above the ground on electric power-supply poles.

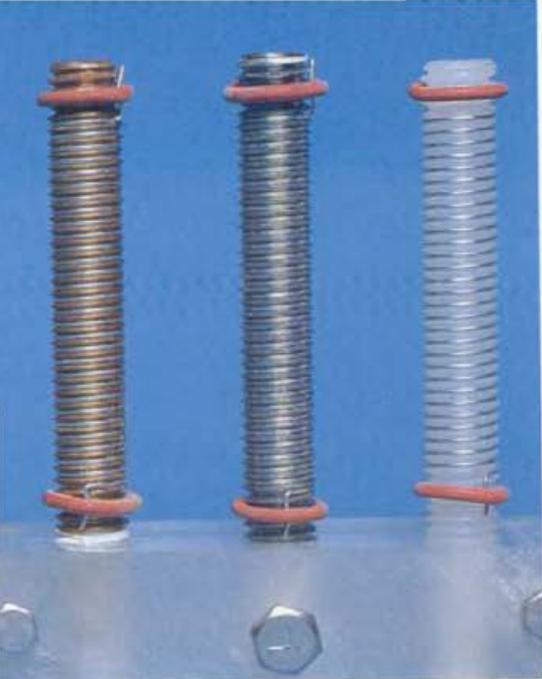
This 'wire-on-bolt' device (to be manufactured by CSIRO under the name 'ATCORR') provides a simple, quick means of assessing corrosion rates.

including modifications to CLIMAT (Classification of Industrial and Marine Atmospheres) testers, developed at the Alcan laboratories in Canada. These units consist of 1-m lengths of aluminium wire wound tightly into the threads of nylon, steel, and copper bolts mounted vertically on a perspex block. They are generally exposed for 3 months and the percentage weight loss on each wire is expressed as a corrosion index.

CLIMAT tests have been carried out at hundreds of locations throughout the world, and correlations have emerged between the indices developed and the service records in existing installations. The wire's high ratio of surface-area to weight, together with a bi-metallic effect that speeds up corrosion, results in the high sensitivity of the device.

In the more recent Melbourne survey, as well as the metal specimens attached to the power poles, Mr King used the Division's versions of these 'wire-on-bolt' units. They were changed quarterly during the 2-year survey period. He found strong correlations between the indices from the units, the distance from the sea, and the corrosion rates of the metals and coatings tested.

As a service to industry the devices are to be manufactured and marketed by CSIRO under the name 'ATCORR' (from Atmospheric CORrosion). It's hoped that ATCORRs will provide a simple means of assessing the level of atmospheric corrosivity at any location in just 3 months.
